## PROPERTY INSPECTION REPORT

**Concerning:** [REDACTED] Lubbock, TX. File # 171118  
(Address or Other Identification of Inspected Property)

**By:** Doug Cox # 6765 11/29/2017  
(Name and License Number of Inspector) (Date)

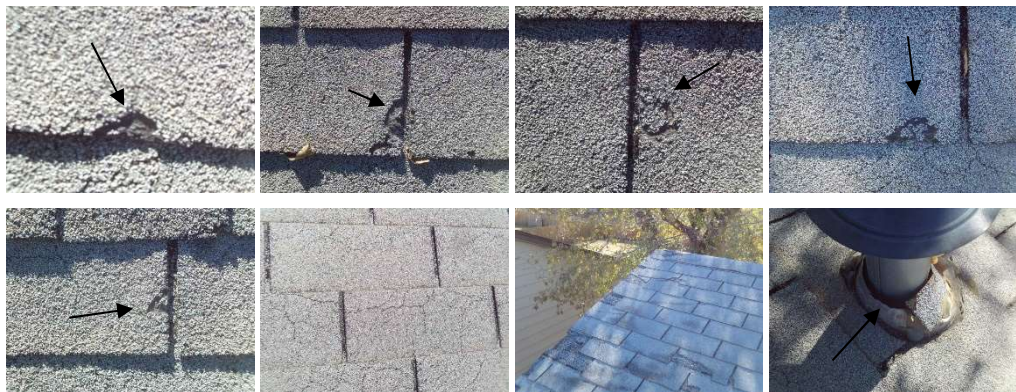
Moderate granular loss (this could be representative of hail damage) and heavy surface cracks (evidence of weathering) was observed across the shingle faces throughout the roof surface; consult a professional roofing company for further evaluation and/or the insurer of your choice prior to purchase to determine the insurability of the roof covering. Example photos below.

Torn and/or damaged shingles were observed at the north slope, south slope and peak ridge adjacent to the east end of the building. Example photo below.

Gaps at the joint between the water heater flue and its penetration flashing should be improved to ensure the water tightness of the roof at this location. Example photo below.

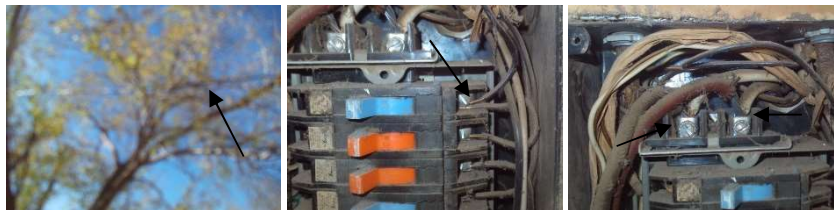
Trees/limbs overhanging and/or in contact with the incoming overhead service wiring should ideally be trimmed away. Example photo below.

Doubled circuit wiring (referred to as a double tap) was observed at a breaker within the main distribution panel located at the laundry room. Consult a licensed electrician for evaluation of this configuration; each circuit should be served by its own separate breaker. Example photo below.

Doubled circuit wiring was observed at the main hot bus terminals of the main disconnect and main distribution panels located at the laundry room. Consult an electrician for evaluation of this installation. Example photo below.
